**Inventory of historically and culturally significant buildings and complexes in Aceh**

<b>No.</b>	009
<b>Name</b>	Ruko China (Chinese Shop houses)
<b>Location</b>	Peunayong (Jl. R.A Kartini)
<b>Present and Past Function</b>	Shop Housese
<b>Date of Inventory</b>	11 August 2005
<b>Literature</b>	Inventory Team

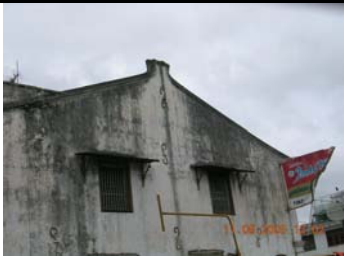
A.3: typical design details

Roof shape	Windows	Arch Corridor
