**Inventory of historically and culturally significant buildings and complexes in Aceh**

<b>No.</b>	010
<b>Name</b>	Art-Deco 'Jengki' Shophouse (Ruko bergaya Jengki)
<b>Location</b>	Peunayong (Jln. R.A Kartini), Banda Aceh
<b>Present and Past Function</b>	Shophouse/office
<b>Date of Inventory</b>	11 August 2005
<b>Literature</b>	Inventory Team

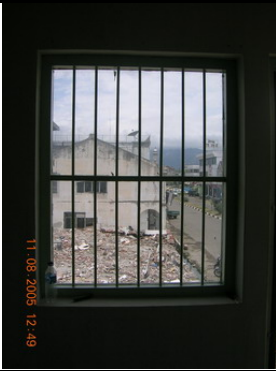
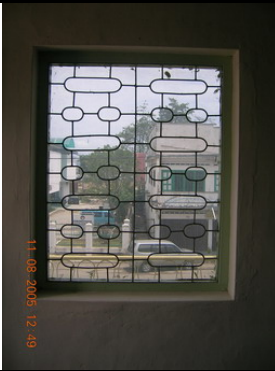
<b>A: the building</b>			
A.1: Plan	-		
A.2: Facades	<p>Front Facade</p>		
A.3: typical design details	<table border="1"> <tr> <td align="center"> <p>Balcony</p> </td> <td align="center"> <p>'Jengki' Column Ornament</p> </td> </tr> </table>	<p>Balcony</p>	<p>'Jengki' Column Ornament</p>
<p>Balcony</p>	<p>'Jengki' Column Ornament</p>

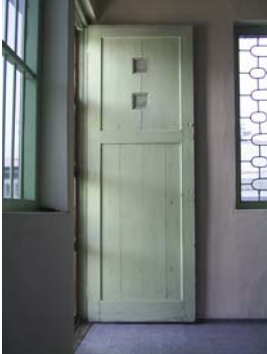
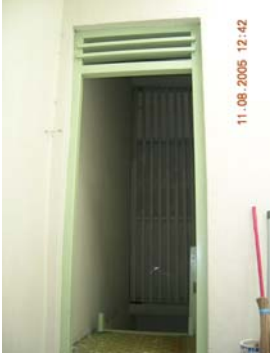
Door	Door frame
