## Inventory of historically and culturally significant buildings and complexes in Aceh

<b>No.</b>	002
<b>Name</b>	SMA Negeri 1 Banda Aceh (ex-MULO School in colonial era)
<b>Location</b>	Esplanade Area (Jl. Prof. A. Majid Ibrahim I, No. 7 Banda Aceh)
<b>Present and Past Functions</b>	Senior High School/ Freemasons' lodge then MULO School
<b>Date of Inventory</b>	April-Dec 2005
<b>Source</b>	Inventory Team, Alfred Kooijman

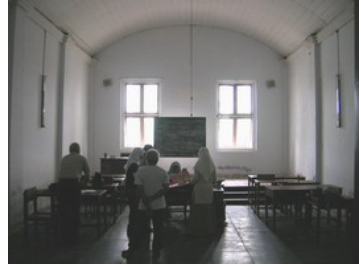
<p>Wooden Ceiling</p>	<p>Concrete Stairs</p>	<p>Ionic Pillars</p>	
<p>B.3: cross-section of the building</p>

<p>Floor (corner)</p>	<p>Floor</p>	<p>Stairs</p>	<p>Column</p>
<p><b>B: building construction</b></p>				
<p>B.1:</p>	<p>Construction methods applied: concrete structure, wooden structures, brick wall construction and zinc roofing.</p>			
<p>B.2: construction details</p>

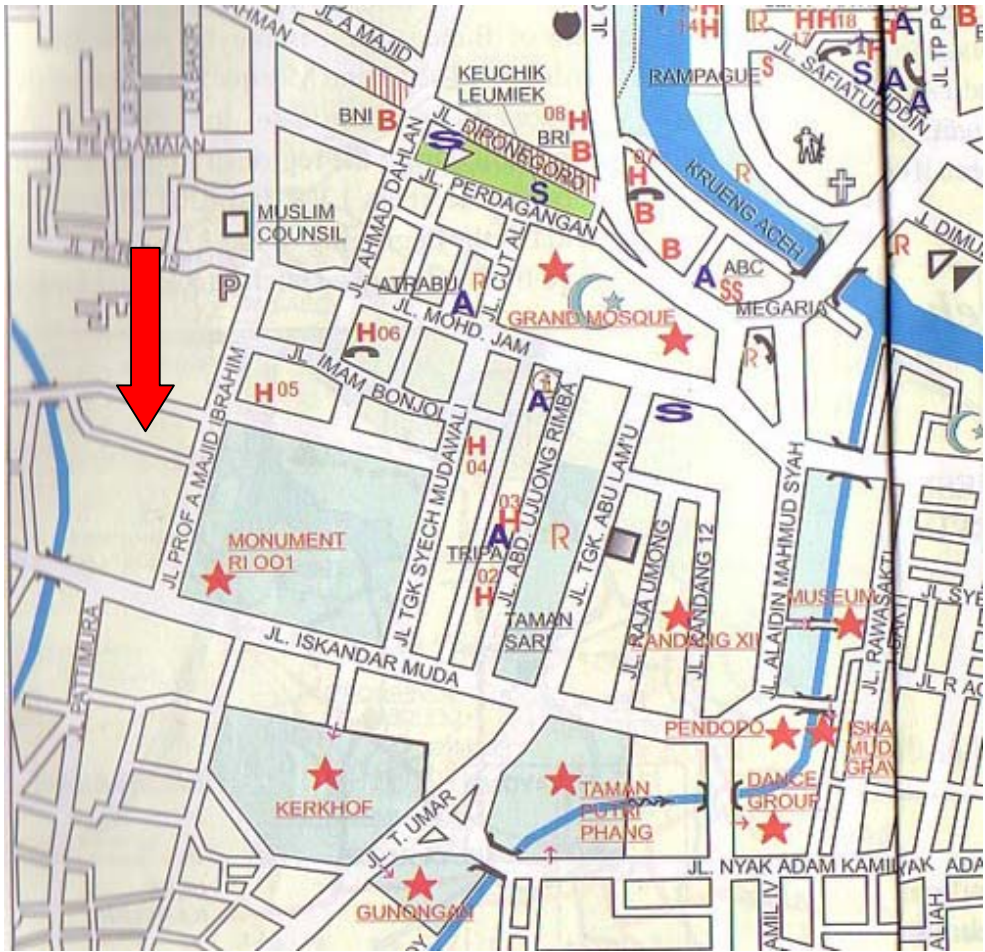
F.1: location

F.2: description	The building is located in the west part of the Esplanade, surrounded by military residential buildings.
F.3: history of the neighbourhood	The features and character of the neighbourhood have not changed much from the time the building was constructed.
F.4: location of the urban
